Evaluation of a 1000-head “Environmentally Friendly Facility” Swine Finishing Barn

Final Report

November, 2001

Prepared by:
Ron Fleming, P. Eng. and
Malcolm MacAlpine

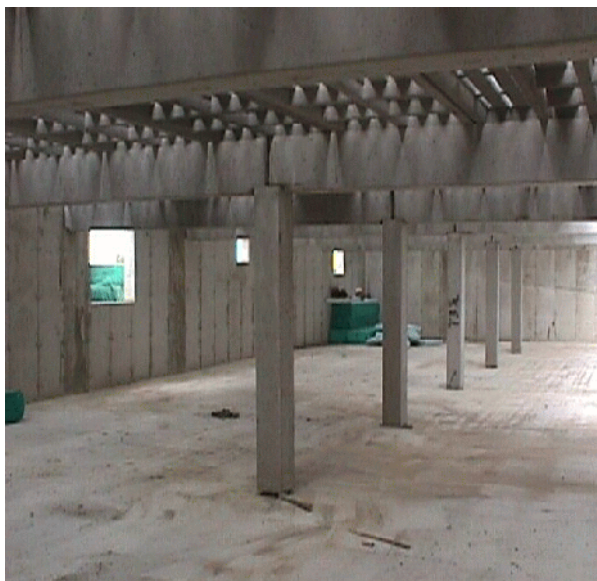
Figure 1 Downstairs in barn, during construction, showing concrete columns supporting slatted floors. Ventilation exhaust fans were installed in wall openings.

The Barn - The barn was constructed in the summer of 2000 on a farm near Exeter, Ontario. Figures 1 and 2 show the barn during construction - Figure 1 showing the lower floor, and Figure 2 showing the upper floor before the barn walls were built. The barn is a fully slatted, fan-ventilated, hog finishing barn. The barn is 51.2 m by 16.76 m (168 ft by 55 ft) with ceiling heights of 2.4 m (8 ft) upstairs and 2.7 m (9 ft) downstairs. The total volume of the lower floor (manure storage) is 2,355 cubic metres (83,160 cubic feet). This depth of manure storage, if used for liquid manure, would be enough to handle the production for just over one full year (about 2,093,000 L), based on 1000 feeder pigs. (estimated using NMAN - OMAFRA, 2000)

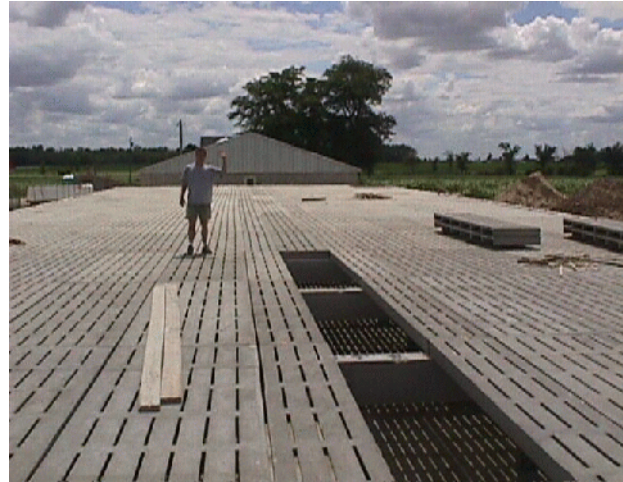
Figure 2 Slatted floor (concrete), nearly complete

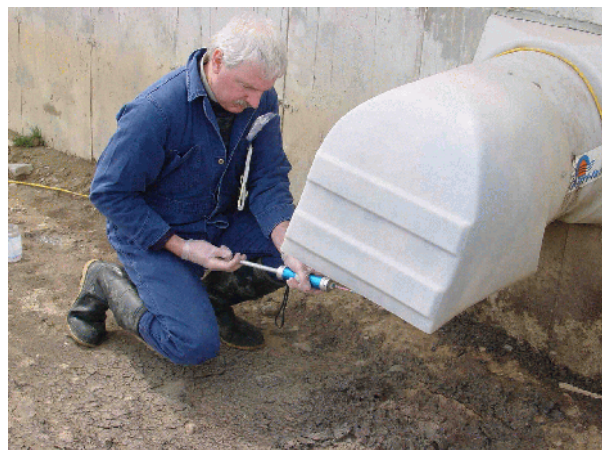
Figure 3 Malcolm MacAlpine taking a reading of the ammonia level at exhaust fan

Ventilation System - With the heavy snow in the winter of 2000/2001, and with the fans mounted on the manure storage walls close to ground level (see Figure 3), some of the Stage Two fans had snow blow into them. This melted and froze, thus preventing the fans from turning. The shafts then broke when the fans started. These fans were repaired in March when it was finally discovered they were not functioning. The shrouding impaired viewing the operation of the fan blades. Even though the fan motors would start and operate as normal, the fan blades were not turning.

Ammonia Levels - Measurements of ammonia (as shown in Figure 3) were made monthly at eight locations - three outside of the barn and five inside the upper floor. The outside locations were: at the continuously running exhaust fan in the southeast part of the barn (designated as FS); at the exhaust fan in the northeast part of the barn (FN); just inside the manure storage door (Man). Inside locations were (all in the upper floor): next to the heater near the north end of the barn (NH); north end between heater and wall (NW); middle of barn (M); next to the heater near the south end of the barn (SH); south end between heater and wall (SW).

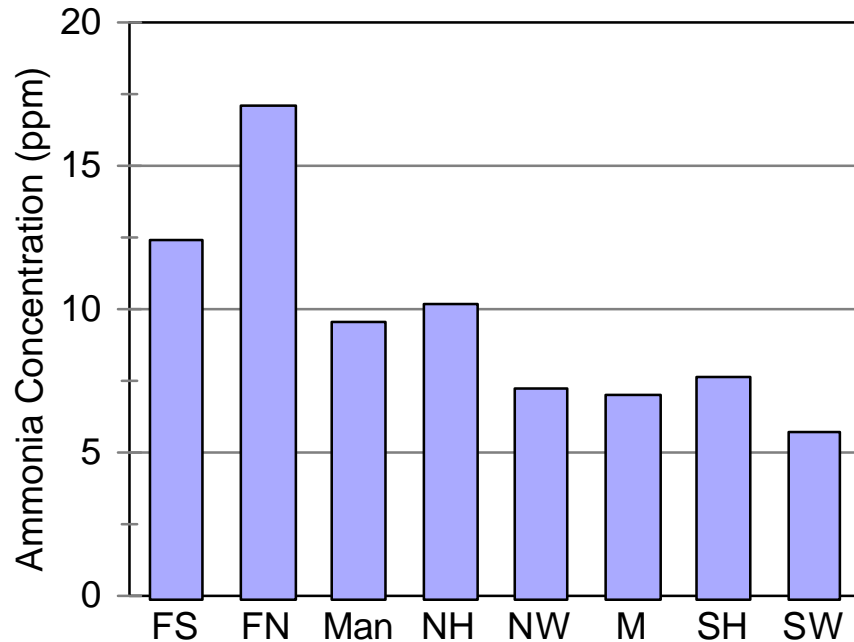
Figure 4 Average ammonia concentrations at different locations:

- FS** - Fan on South end of barn - outside
- FN** - Fan on North end of barn - outside
- Man** - Measured just inside manure storage door
- NH** - Next to heater on North end of barn - inside pig area
- NW** - between heater and wall - North end - inside pig area
- M** - Middle of barn - inside pig area
- SH** - Next to heater on South end of barn - inside pig area
- SW** - between heater and wall - South end - inside pig area

The averages of the monthly readings are shown in Figure 4. Ammonia levels measured in the manure area were an average of 10 ppm. Ammonia levels were higher in the air leaving the North-East exhaust fan (avg 17 ppm) than the South-East fan (avg 12 ppm). Inside the barn, ammonia levels were higher in the North end (avg of 10 ppm) than the South end (avg of 7 ppm). The north half of the barn had mesh pen fronts and the south half of the barn had solid pen fronts

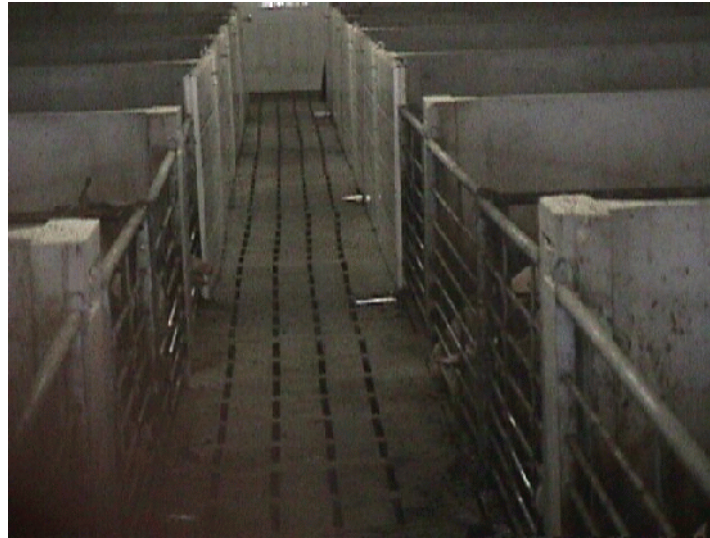
Figure 5 Open vs solid pen fronts

(see Figure 5). Ammonia levels in the barn were much lower after March, 2001. The main reason for the high readings during the first several months is believed to be due to problems with the exhaust fans. The second stage ventilation fans froze and the shafts broke at some point during the winter, resulting in less air exhaust than was required. The fans were repaired in late March. Further evidence of ventilation system problems may be found by examining the relative humidity data for the room - during November and December, the relative humidity was higher than 80% most of the time (the temperature stayed very close to 21° C during this period). For a grower-finisher barn such as this, it should be possible to keep the RH at 75% or lower, even without supplemental heat (Huffman, 2001). This helps confirm that the exhaust rate was lower than it should have been, which would have contributed to higher barn ammonia levels. Even considering this ventilation problem, the ammonia levels were no higher than typical slatted floor barns with liquid manure under the slats. These values would be in the range of 15 to 30 ppm, with occasional values of over 40 ppm - and 5 to 10 ppm in the summer (Huffman, 2001).

The pigs did not manure uniformly over the floor area, thus some areas in the bottom floor were still quite dry while other areas were getting wet. Manuring may be influenced by the layout of the penning in the barn. The north half of the barn has mesh pen fronts, allowing hogs to socialize across the center alleyway. The south half has solid pen fronts.

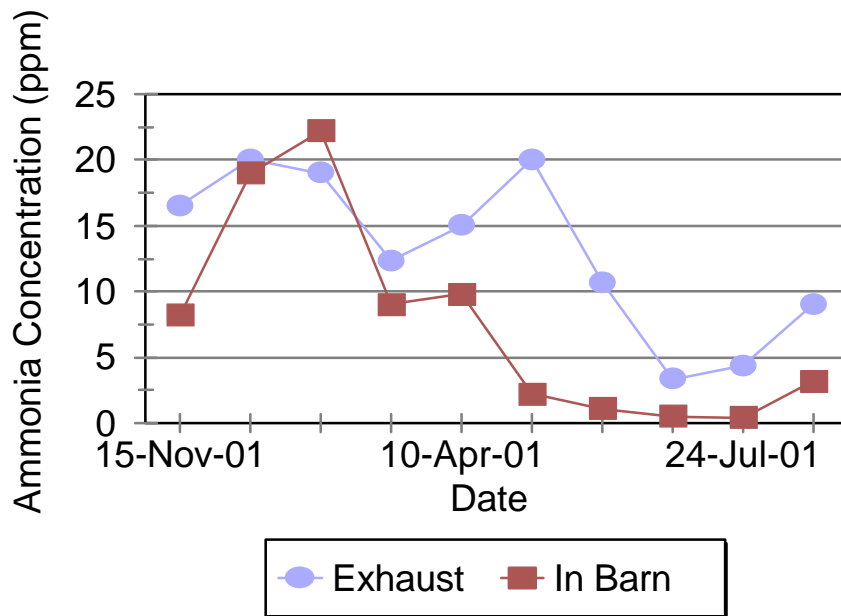
Figure 6 Average ammonia readings inside the barn and in the exhaust air, during the study period (inside - 5 locations, exhaust - 3 locations)

The warmer weather with higher ventilation rates helped lower the ammonia readings in this barn to less than 5 ppm from May until clean out. Variations in ammonia readings over time are shown in Figure 6.

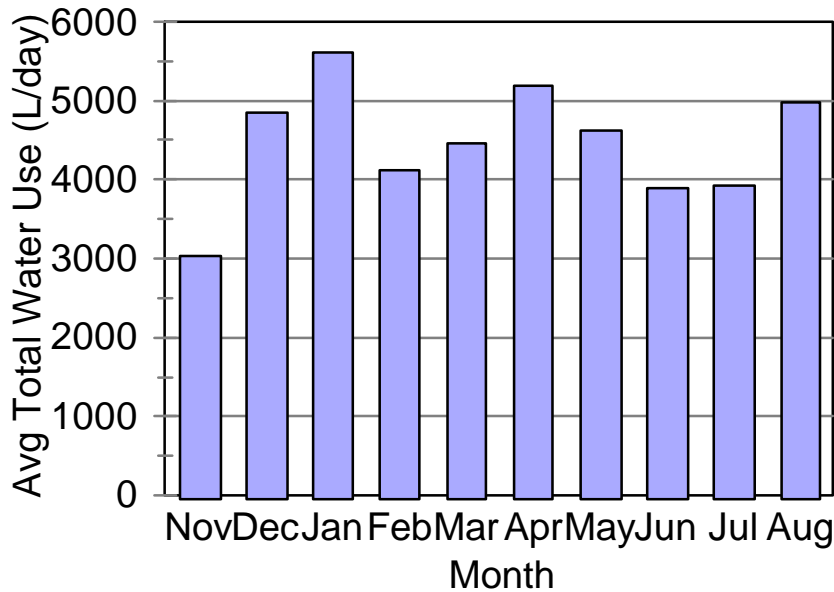
Figure 7 Total water use per day, averaged by month, over the study period

feeders in hog barns, Fleming et al. (1999) measured an average water consumption of 5.5 litres per pig per day for conventional barns using wet/dry feeders, and 7.9 litres per pig per day for conventional barns using dry feeders. The relatively low water use in the study barn suggests the barn is successfully set up to reduce wasted water. This is accomplished in part by the use of wet dry feeders (that tend to reduce the amount needed). Total water used over the period specified was 1,481,000 litres (325,780 gallons). The monthly variation in water use is shown in Figure 7.

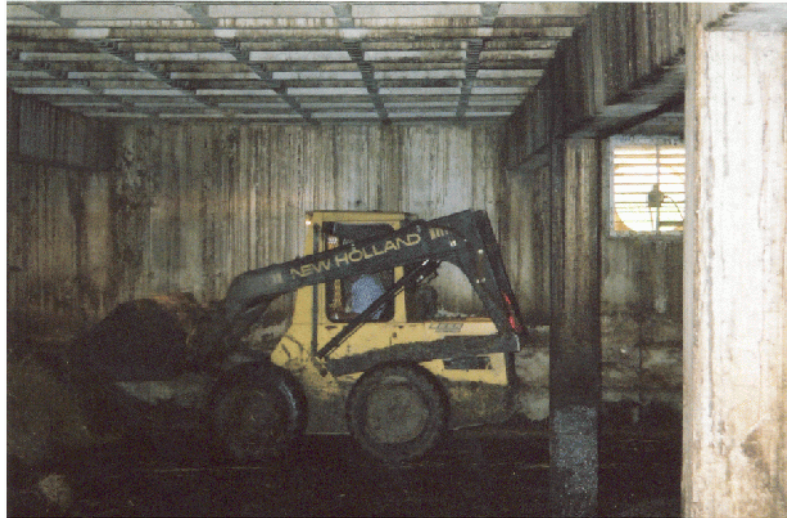
Figure 8 Skid steer loader moving below the slatted floor during unloading

The skid steer could easily be operated in the spacious manure storage with only two rows of columns to negotiate. The operation required three operators - one on the skid steer, and one driver for each spreader. The manure was spread approximately two km away on a harvested wheat field. The speed of emptying the storage was limited by the size of equipment used and the distance to draw the manure.

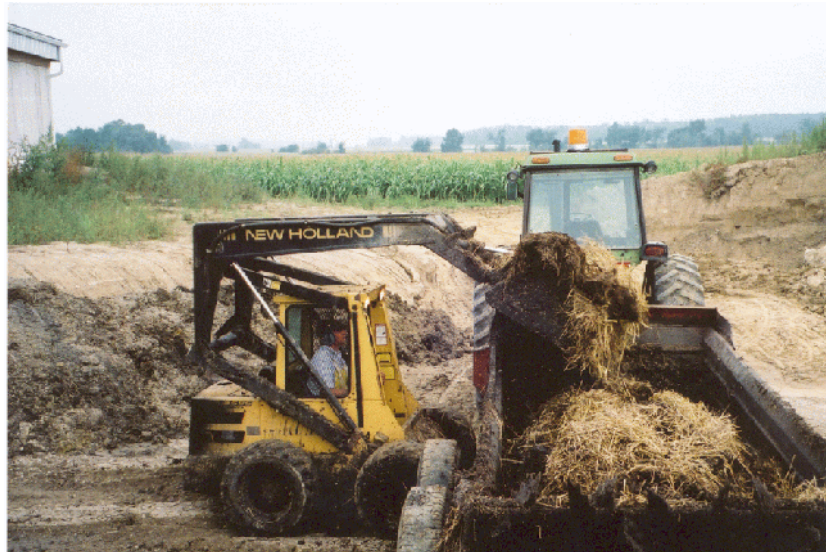
Figure 9 Loading solid manure spreader

Two dry manure spreaders were used. Each had a capacity of 14.5 cubic meters (400 bushels) and each was equipped with hydraulic end gates to prevent any sloppy manure from flowing out during transportation. The manure was moved out of the manure storage using a skid steer loader (see Figures 8 and 9) which had to drive out the centrally-located access doorway to the spreaders parked just outside the manure storage. The clearance was not great enough that the manure spreaders could be parked inside the manure storage for loading.

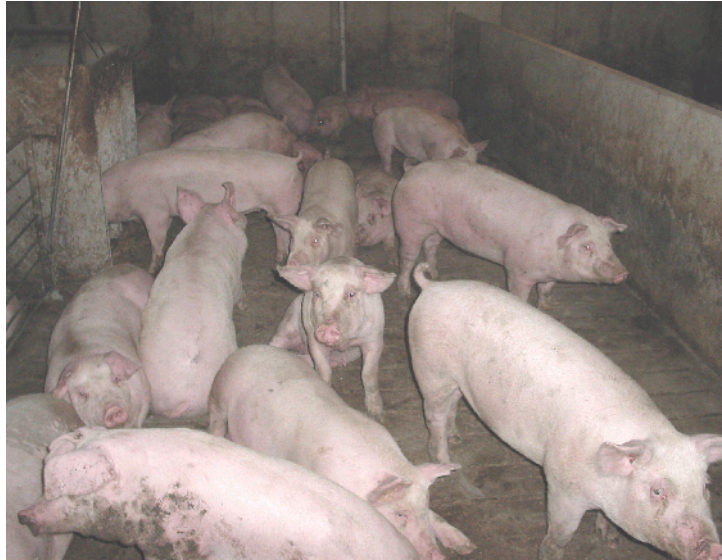
Figure 10 Feeder pigs in group pens with slatted floor
